PhD THESIS

SUMMARY

**INFLUENCE OF MARTENSITIC STAINLESS STEEL QUALITY ON
HYDRAULIC TURBINES LIFETIME**

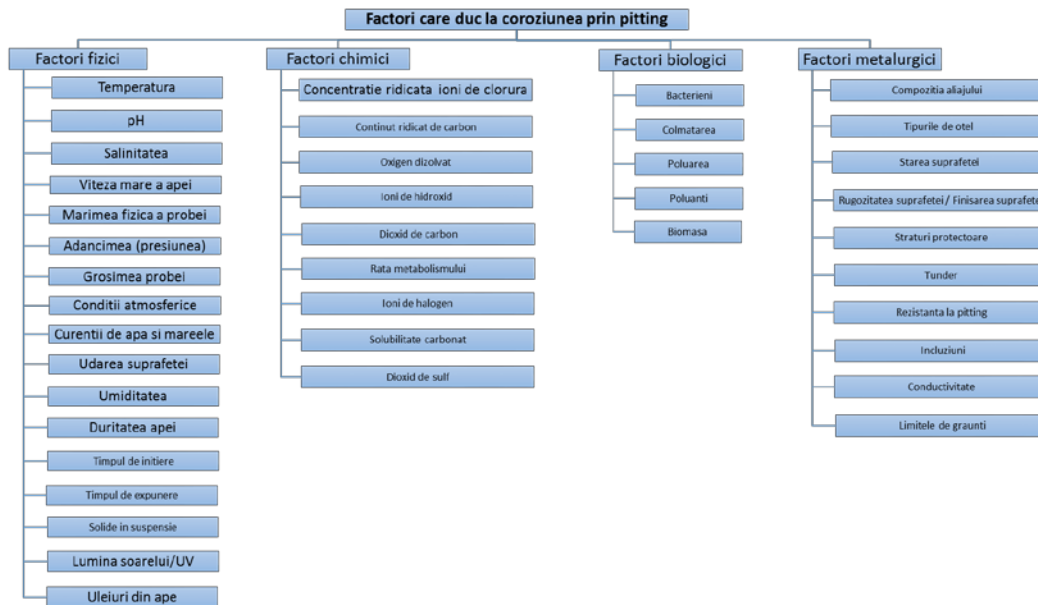
Fig. 2.1. Factors that can affect point corrosion

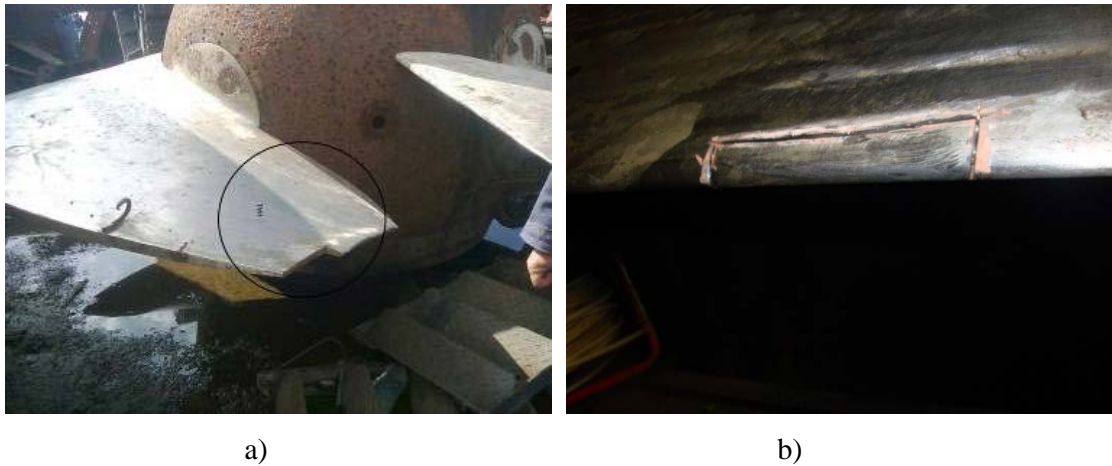
Fig. 3.2. Sampling of hydroelectric turbines on the Olt river a) Izbiceni b) Frunzaru

For investigations on the technical state of the turbines on the Olt river, we used samples taken from blades from the Izbiceni and Frunzaru hydropower plants made of martensitic stainless steel. Samples were manually cut by cross-section and longitudinal sectioning. During the sampling, overheating was avoided.

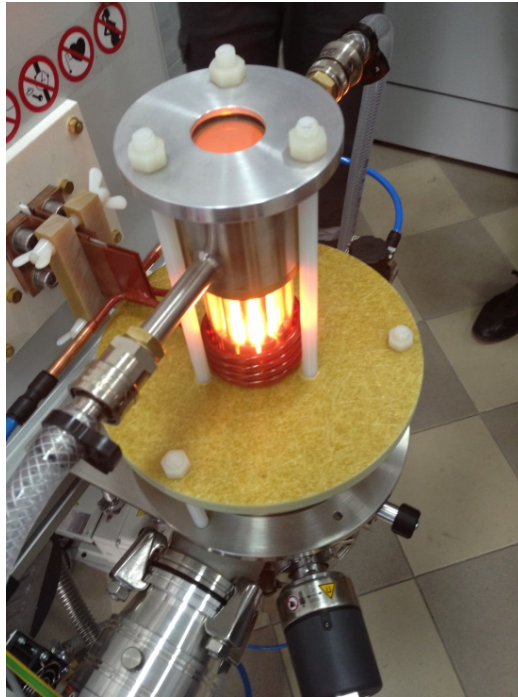
Fig. 3.3. Cold-chamber furnace, with vacuum and argon atmosphere

The stainless steels used for the experimental research have been developed in a cold-crucible furnace, with vacuum and argon atmosphere, such as the Fives Celes ALU 600.

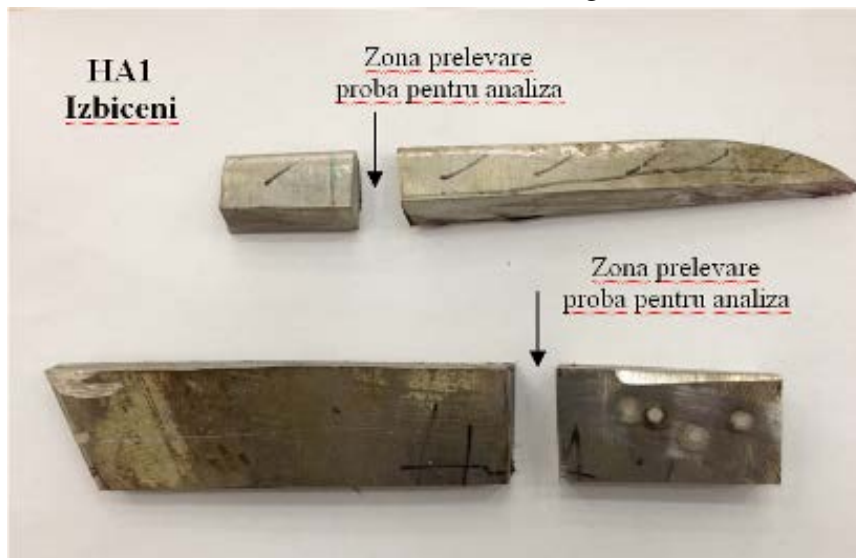
Fig. 4.1. The appearance of the sampling areas analyzed

In order to analyze the state of the turbine material at Izbiceni, samples were taken from the HA1 palette. The appearance of the HA1 rotor blade is shown in Figure 3.1 a.

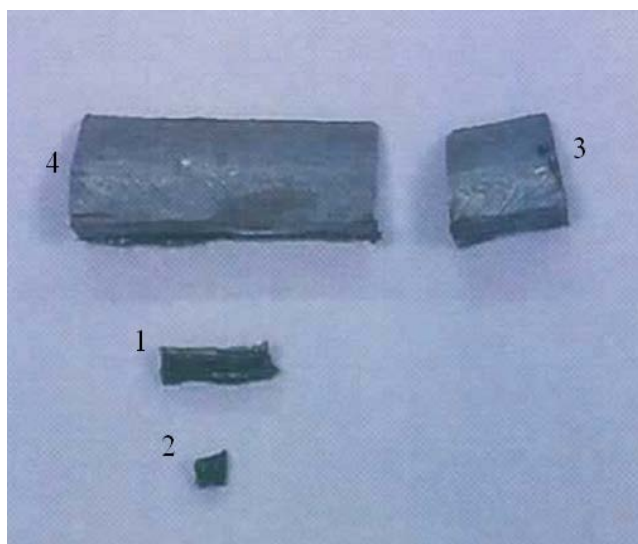
Samples 1 and 2 were taken from the corrosion-affected area (Figure 4.3) and samples 3 and 4 were taken from the edge of the blade (Figure 4.16).

Fig. 4.6. Samples taken from the turbine rotor blade

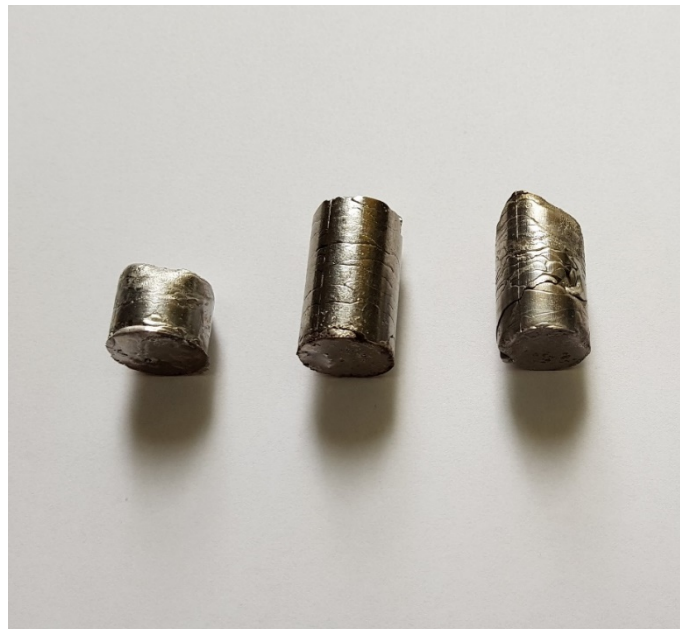
The elaboration of the stainless steels subjected to the research was done in an induction furnace with a cold copper crucible with an inner diameter of at least 35 mm and the capacity of min 8 cm³ and max 15 cm³ equipped with a casting plug, figure 3.2. The operating parameters of the furnace are: nominal power 25 kW, frequency HF 100 - 400 kHz, apparent power 40 kVA, phase current 40 A, power factor 0.92, minimum water flow 12 l / min, maximum inlet pressure: 7,5 bar, water inlet temperature: max. 24 ° C. The maximum working temperature of the oven is 2800 °C and the vacuum system contains a primary vacuum pumping station including a pump of at least 1.7 m³ / h with a vacuum limit of 10⁻⁴ mbar and a vacuum pump pumping station: 1x10⁻⁸ mbar.

Fig. 5.1. Stainless steel ingots made in the induction furnace with a cold crucible

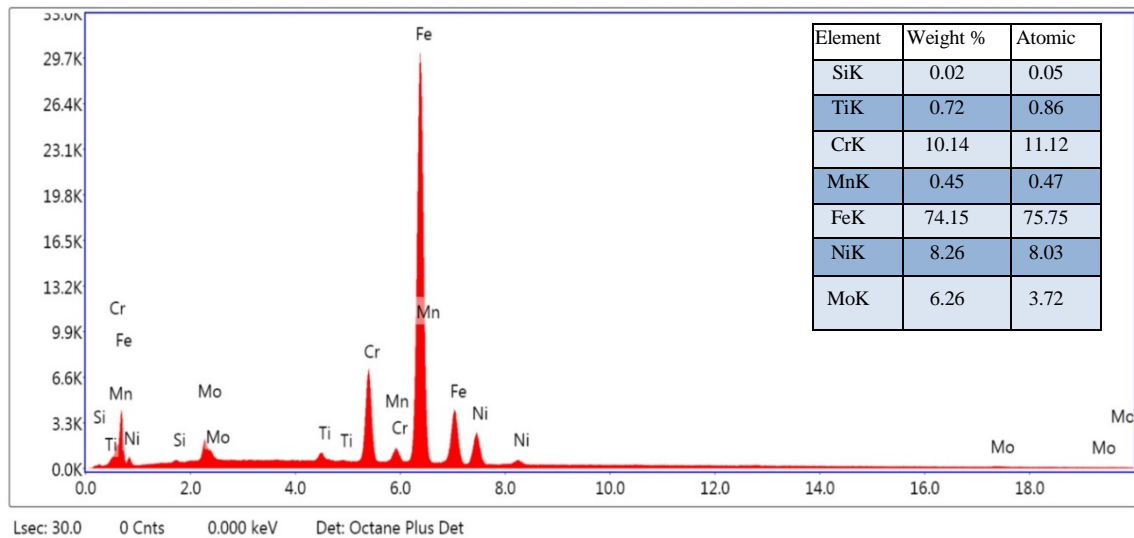
Fig. 5.10 Spectrum EDS and chemical analysis in the selected area (1)

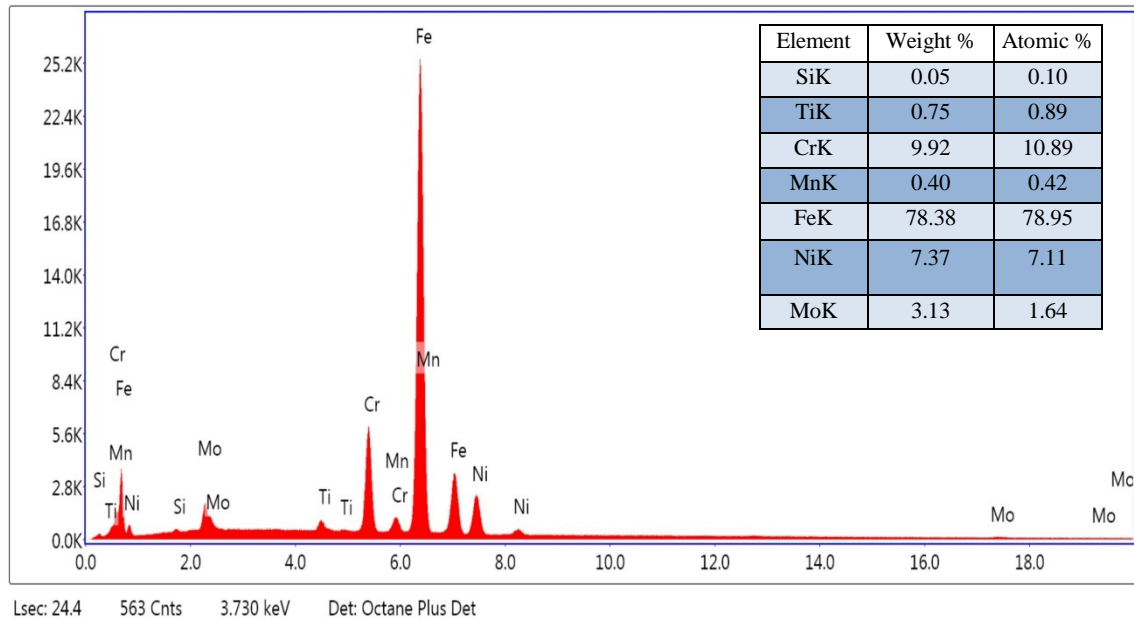
Fig. 5.14 EDS spectra and chemical analysis in the selected area 1

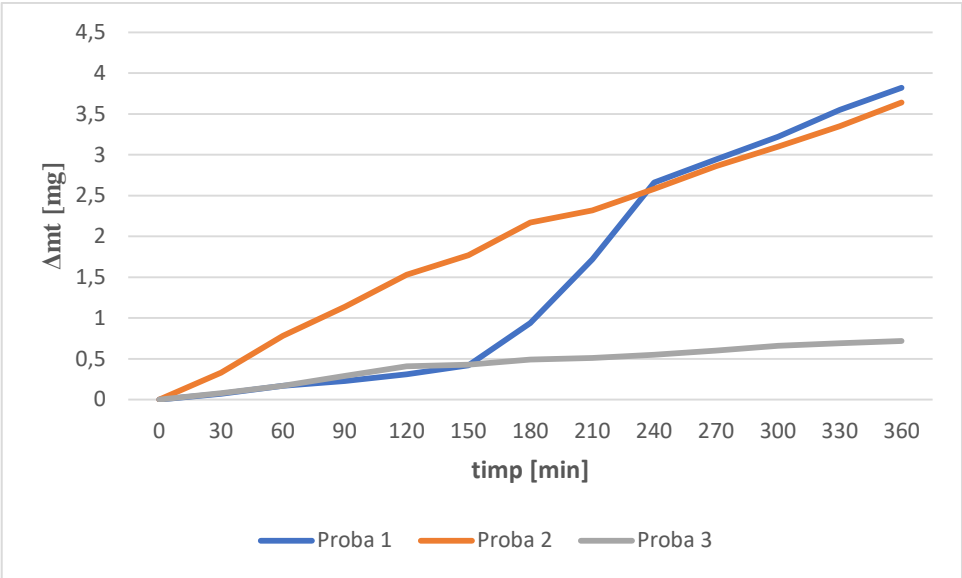
Fig. 6.2 Variation of total eroded mass at samples 1, 2 and 3
