**UNIVERSITY POLITEHNICA OF BUCHAREST
THE FACULTY OF MATERIAL SCIENCE AND ENGINEERING**

**PhD THESIS
SUMMARY**

**EVALUATION AND CONTROL OF
MICROBIOLOGICALLY INFLUENCED
CORROSION IN OIL INDUSTRY USING A
BIOFILM SAMPLING DEVICE**

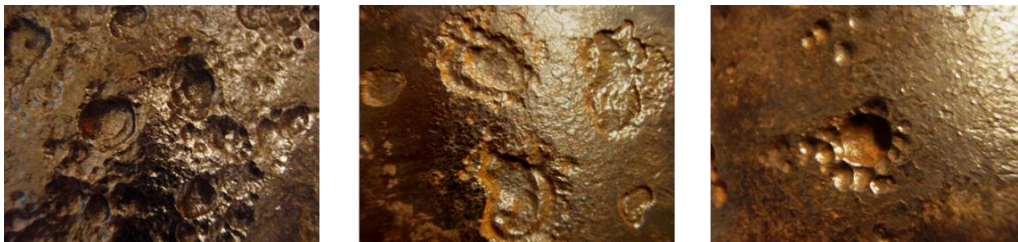
Fig.2 Terraced pitting specific of MIC

MIC is a type of localized corrosion that results from the activity of microorganisms in the form of pitting corrosion, crevasse corrosion or corrosion under deposit [16]. MIC is mainly characterized by localized terraced pitting [17].

MIC is usually observed in the form of pitting under deposits or tubercules, with the role in protecting microorganisms from the external environment. Corrosive attack is often characterized by cup-shaped and terraced pitting or underground cavities in carbon steel [2]. Moreover, the pitting can act as an initiator of stress corrosion cracking (SCC), because the "root" of the pitting causes the applied stress to multiply, resulting in much greater efforts than the tensile strength, thus causing damage to the metal [20].

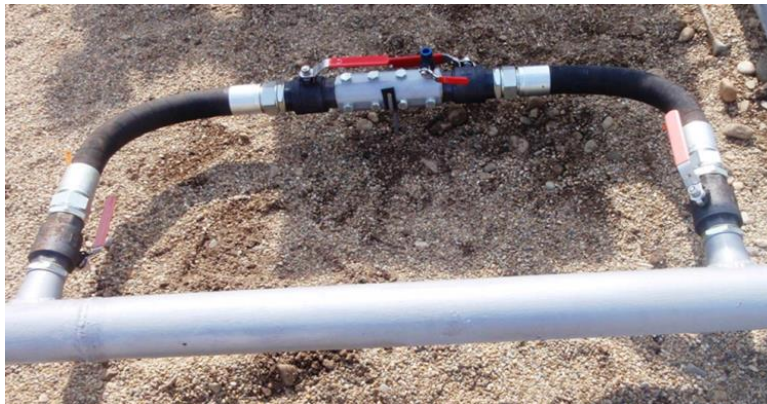
Fig.3 The device installed in location no.1

The device can be installed on any pipeline where microbial activity has been identified. It accumulates several components of the oilfield system, such as the biofilm containing sessile bacteria, the fluid flowing through the pipeline and corrosion products.

The importance of the device is given by the facts it allows assessment of microbiological activity by biofilm accumulation, it is sealed and prevents air contamination, reproduces exactly the natural conditions of bacteria attachment on metal surface and allows transportation of collected fluid and biofilm to the laboratory, maintaining the same natural environmental conditions (pressure, gas content, fluid and biofilm composition and so on).

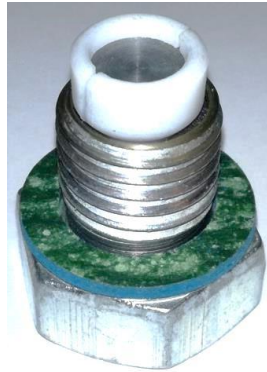
The main part of the device is the special stud with the metal coupons on which biofilm accumulates. The coupons are mounted in a teflon protection, manufactured in two parts, which can be unfold in order to take out the coupons without biofilm contamination. 15 metal coupons are exposed internally into the device, located in “12”, “3”, “6”, and “9 o’clock” positions on the circumference of the device, to compare bacterial growth.

Fig.4 The special stud

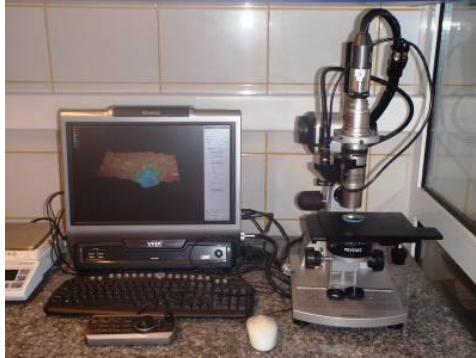
The characteristics of the metal surface were examined using the Keyence digital microscope and the Philips scanning electron microscope (SEM).

Fig.6 Keyence digital microscope

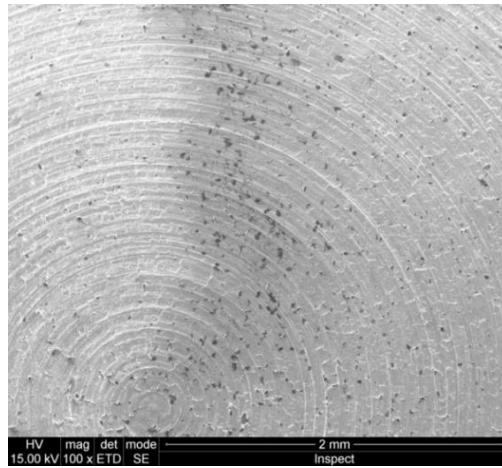
The chemical composition of the metal was determined by the spectrochemical method [27]. The chemical composition of the metal corresponded to a non-alloy carbon steel, type AISI 1035. The metallographic examination of the surface showed non-metallic oxide inclusions according to ASTM E45 [28] and homogeneous structure of ferrite and perlite, specific to carbon steel. The characteristics of the metal surface were examined using a digital microscope and SEM, to observe and compare the changes that will occur after the corrosive attack.

Fig. 7 SEM image of metal surface, 100X

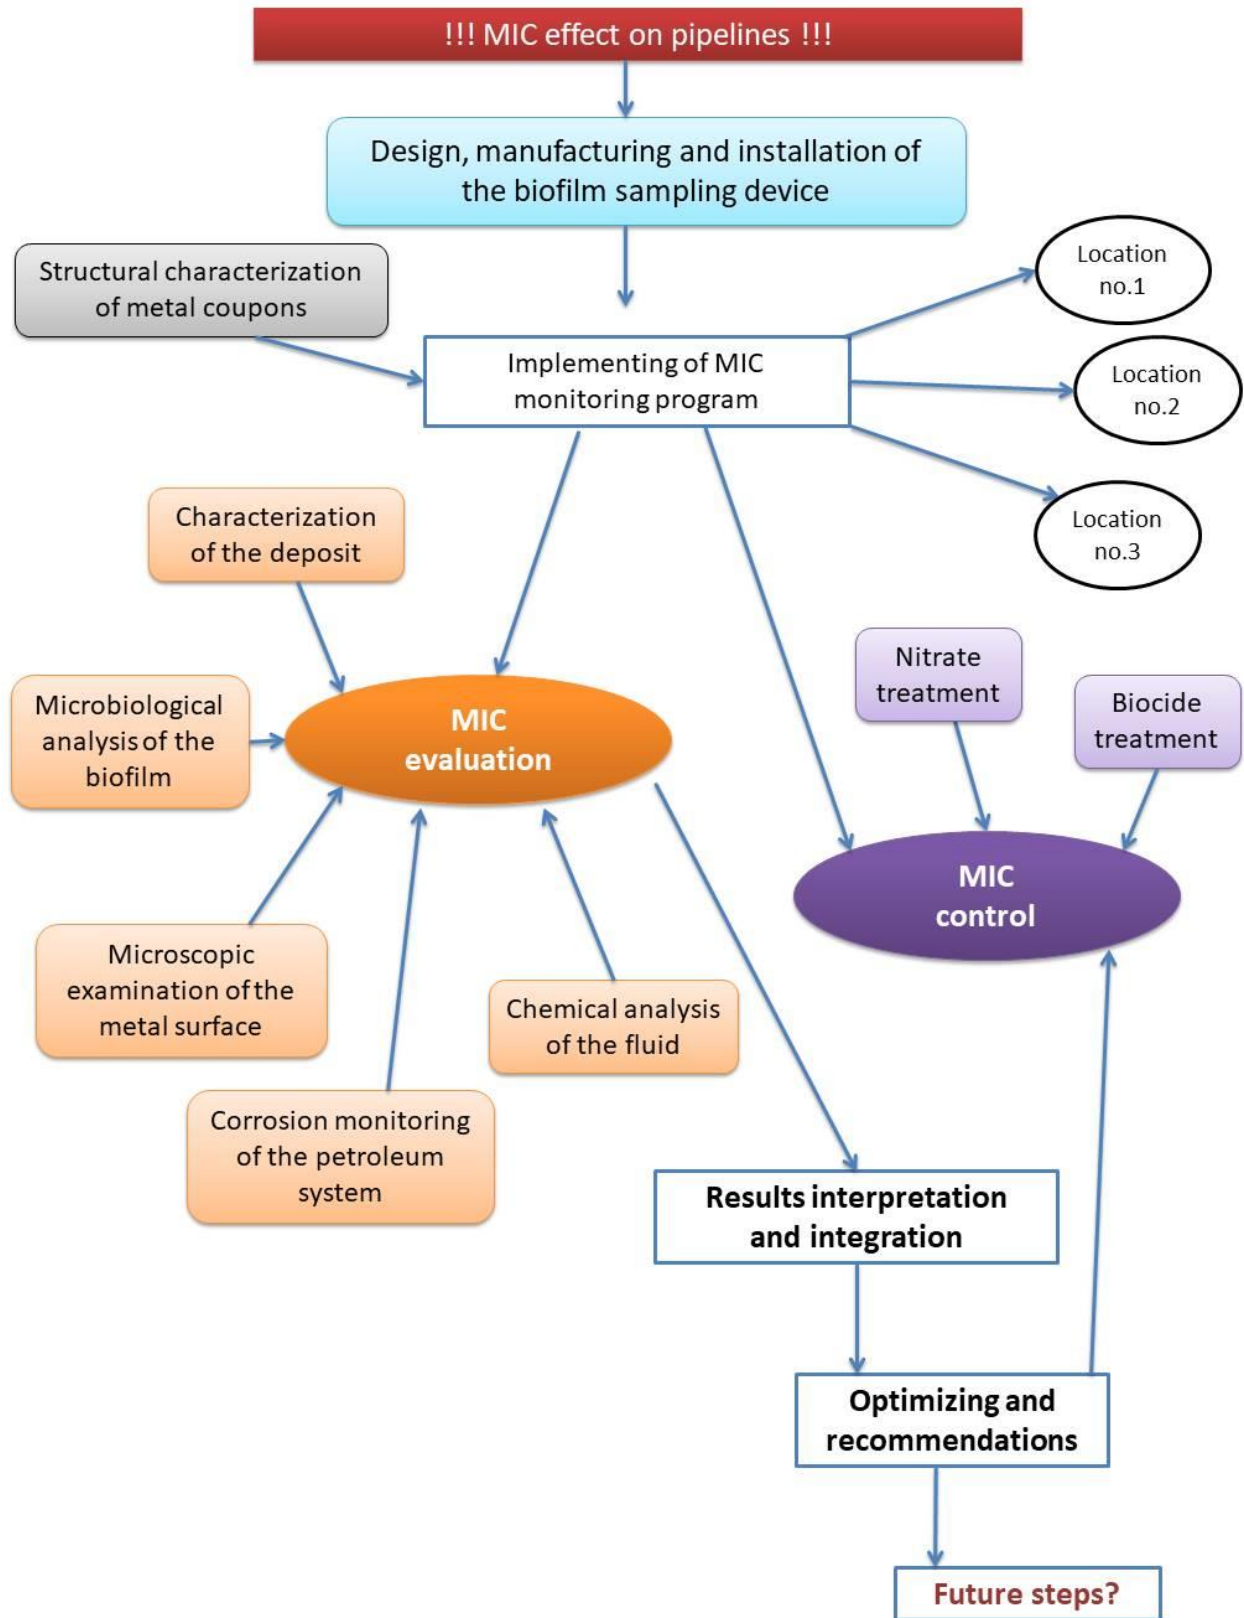
The experimental program performed within the present PhD thesis is shown in figure 8.

Fig.8 The experimental program of the research carried out within the present PhD thesis

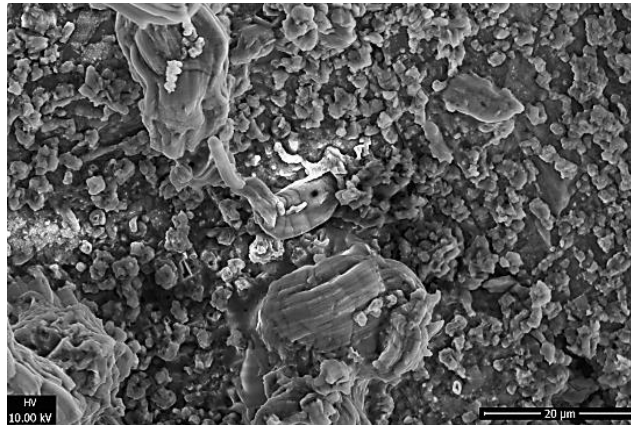
The morphology and the elemental composition of the deposit were characteristic of scale deposit, containing inorganic particles, especially salt crystals, in different hydration phases. Due to the large amount of salts, the microbiological mass could not be differentiated, except for the deposit taken from the "12 o'clock" position, where bacteria-like forms may have been identified.

Fig.8 Scanning electron micrograph of the deposit from “12 o’clock” position, 5000X

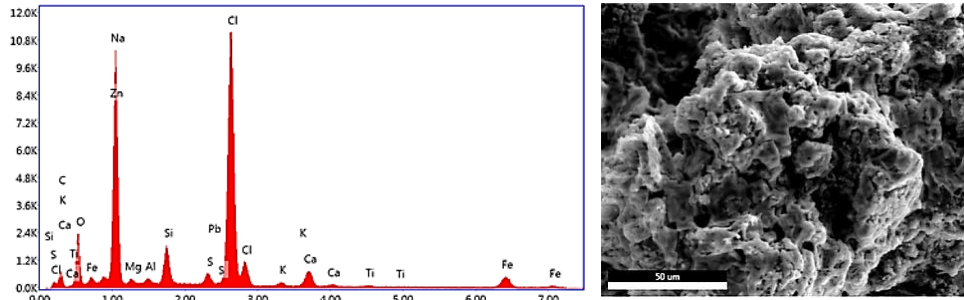
The elemental composition of the deposit corresponds to scale type, containing high amount of salts, represented by Na and Cl compounds. Zn is naturally present in water and, therefore, in the hydrated deposit. Also, silica, oxides and carbonates are present, represented by Si, O and C. The corrosion products identified are Fe, Mn and Cr. As presence in the spectrum can classify the scale as calcium carbonate type.

Fig.9 EDS spectrum of the deposit and SEM micrograph of sample from which spectrum was generated

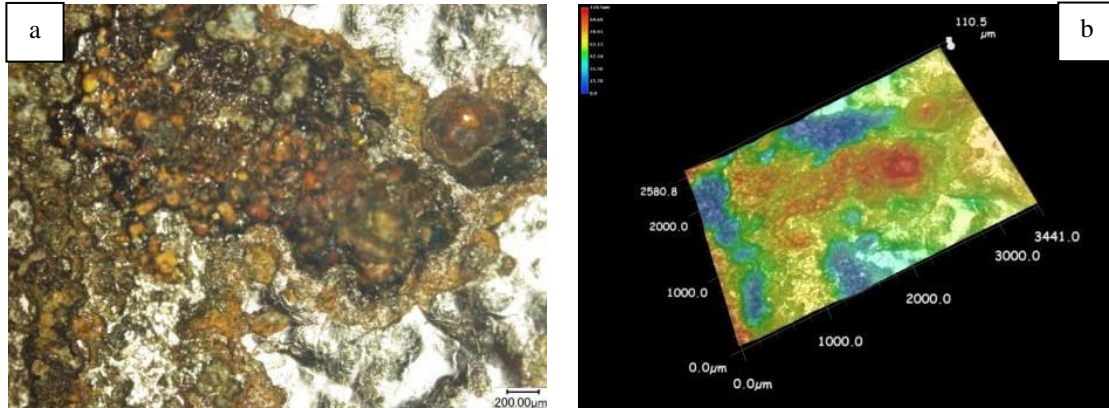
- "12 o'clock" and "6 o'clock", as localized shallow pitting, in monitoring campaign 2;
- "12 o'clock" and "9 o'clock", as localized shallow pitting, in monitoring campaign 3;
- "3 o'clock", as terraced pitting and, respectively, "12 o'clock" and "9 o'clock", as localized shallow pitting located, in monitoring campaign 5;
- in all positions, as terraced pitting, in monitoring campaign 6;
- "6 o'clock", as terraced pitting, in monitoring campaign 7.

Fig.10 2D (a) and 3D (b) micrographs of the metal surface in "6 o'clock" position, monitoring campaign 7, 100X

The corrosion intensity was higher on the surface of metal coupons from "6 o'clock" position, where the predominant type of corrosion was general corrosion. The intensity of corrosion can be correlated with high bacteria number in biofilm samples.

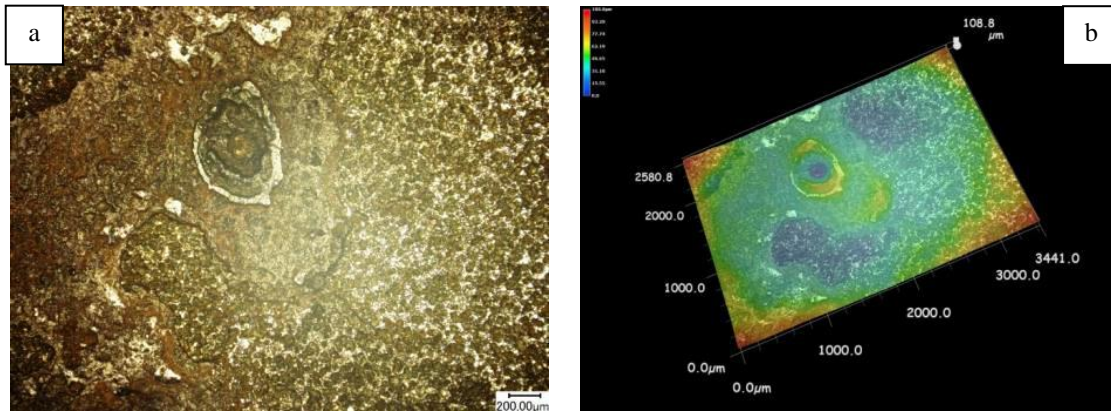
- "6 o'clock" and "9 o'clock", as terraced pitting, in monitoring campaign 2;
- "3 o'clock", as localized shallow pitting, in monitoring campaign 3;
- "12 o'clock" and "3 o'clock", as localized shallow pitting, in monitoring campaign 4.

Fig.11 2D (a) and 3D (b) micrographs of the metal surface in "6 o'clock" position, monitoring campaign 2, 100X

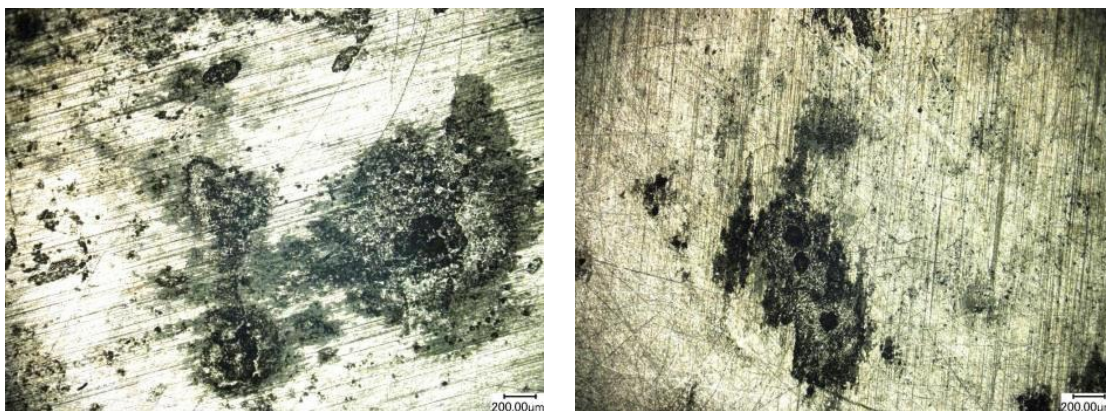
- "3 o'clock" and "9 o'clock", as terraced pitting, respectively "12 o'clock", as localized shallow pitting, in monitoring campaign 1;
- "12 o'clock" and "3 o'clock", as terraced pitting, respectively "6 o'clock" and "9 o'clock", as localized shallow pitting, in monitoring campaign 3.

Fig.12 2D micrographs of the metal surface in "12 o'clock" position, monitoring campaign 3, 100X

MIC appearance on metal surface was influenced by the longer period of exposure, being observed very representative morphologies. Also, the intensity of MIC was determined by the lack of biocide treatment, the development of the biofilm not being influenced.
